I.P.E. MILANO - ODV

LA VALUTAZIONE VISIVA DEGLI IMMOBILI

L'ESPERIENZA DELLA SCHEDA AEDES: USO E RISULTATI

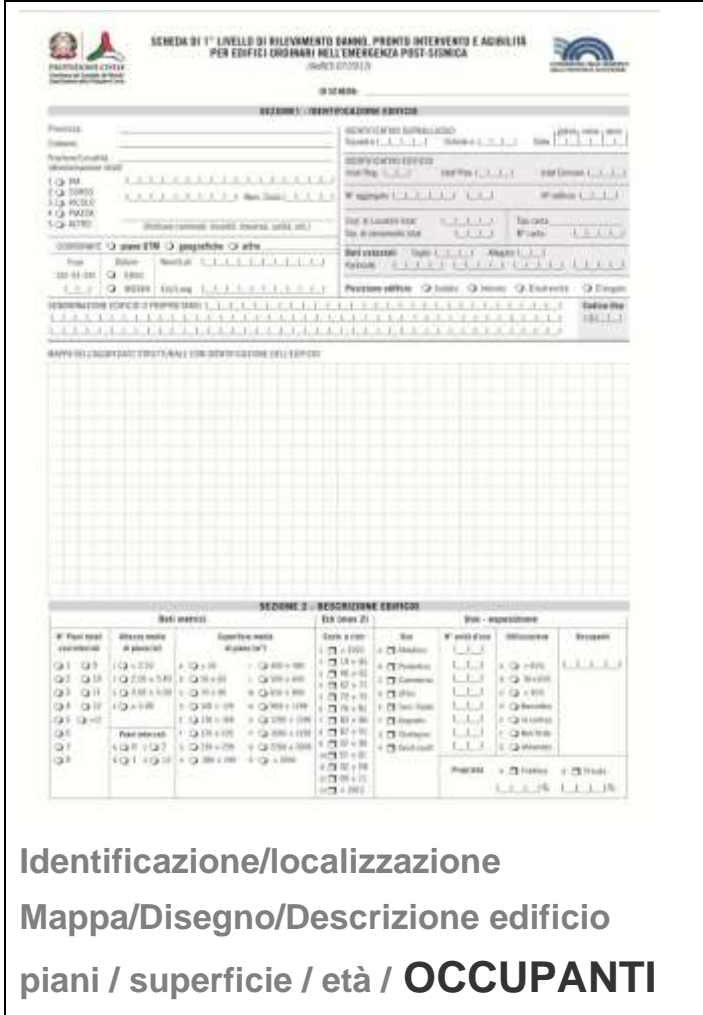
SCHEDA AEDES (VERSIONE 2013)

SCHEDA DI 1° LIVELLO DI RILEVAMENTO DANNO, PRONTO INTERVENTO E AGIBILITÀ PER EDIFICI ORDINARI NELL'EMERGENZA POST-SISMICA

Strumento via via affinato da Pro.Civ per **UNIFORMARE** i giudizi tecnici e comparare grandi quantità. Scheda in apparenza semplice, ma richiede profonda conoscenza delle caratteristiche più importanti. La corretta compilazione delle varie sezioni tecniche, porta ad esprimere in sintesi il giudizio di agibilità:

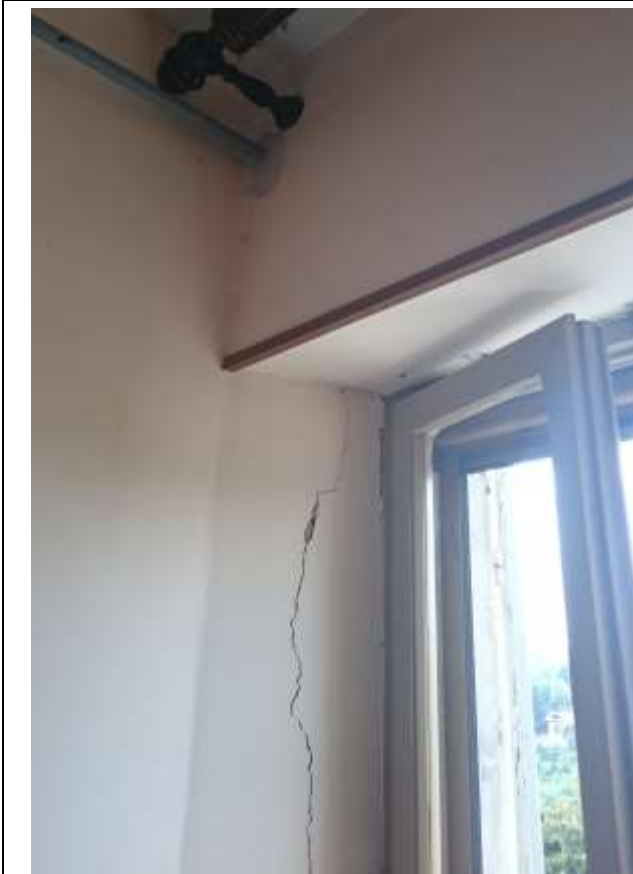
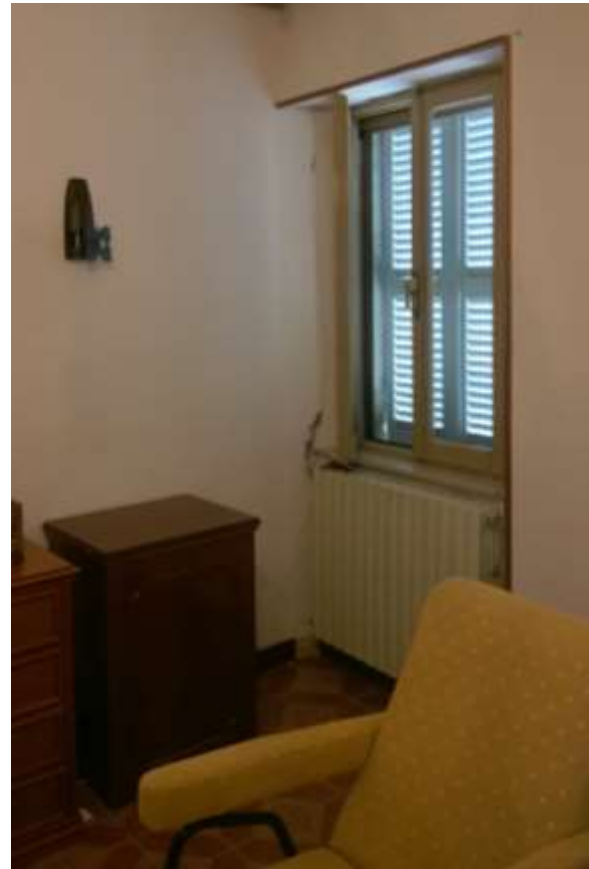
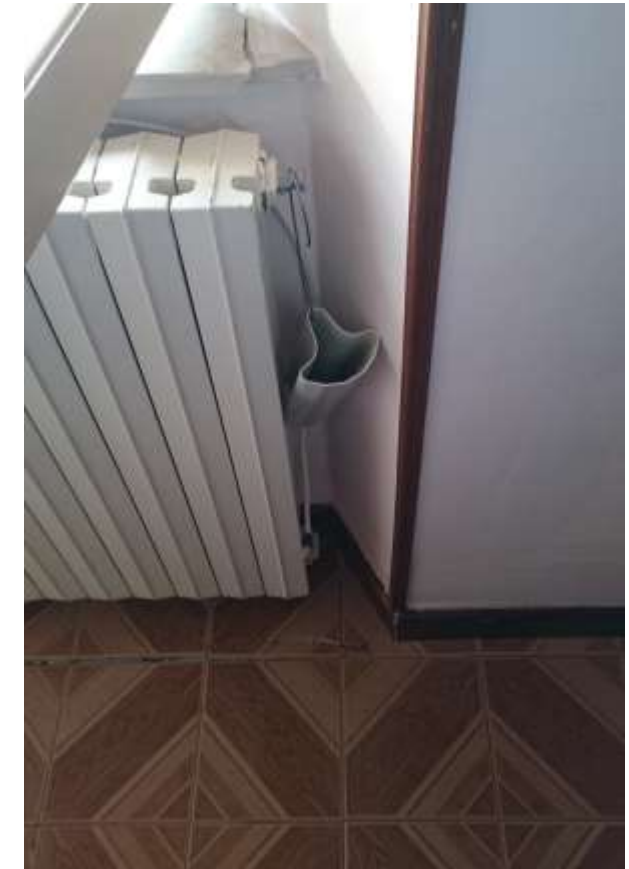
UN ESEMPIO INGANNEVOLE : I DANNI

... Non molti danni, ma a pavimento qualcosa di strano:
Le murature sono assolutamente staccate dal solaio (travi parallele)

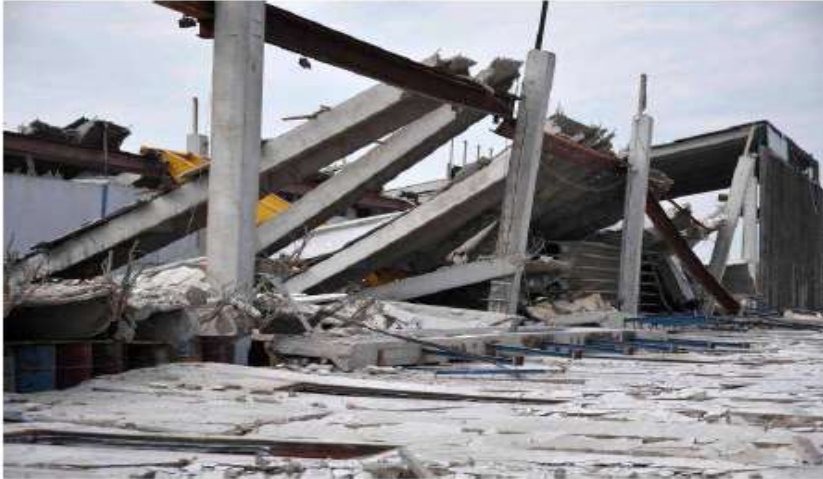
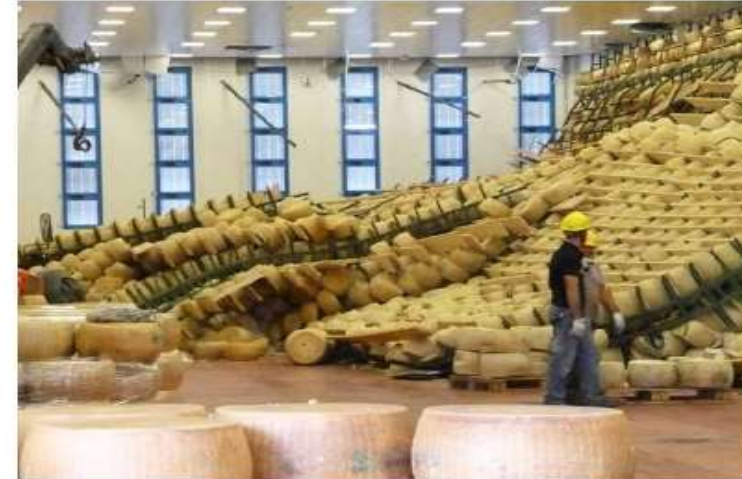
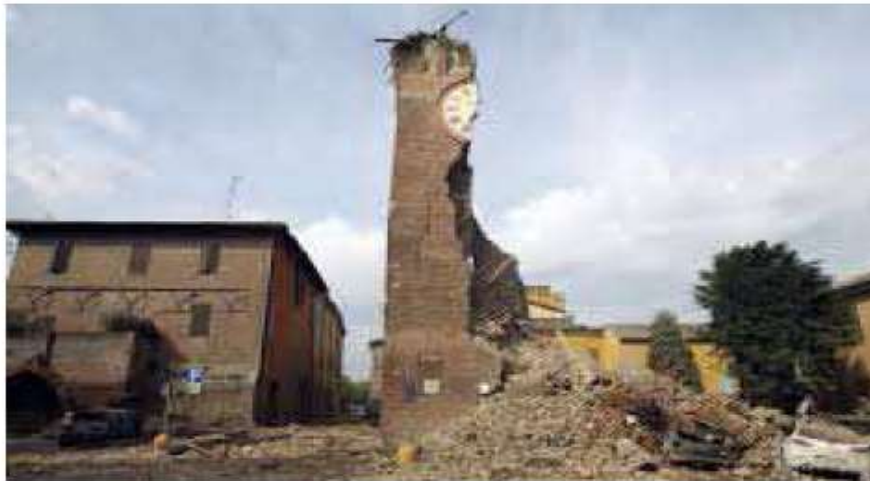
IL SISMA in EMILIA DEL 2012 – La nascita di I.P.E.

Si riscontrano danni in diverse tipologie di costruzioni:

- **Capannoni**; gli elementi si disarticolano per mancanza di connessione dei nodi; dopo il crollo gli elementi sono comunque riconoscibili
- **Scaffalature interne**: Non studiate, specialmente dal vista sismico, per il peso che devono portare.
- **Edifici in muratura**, sia in mattoni pieni che in pietra.

Le prime due tipologie di crolli hanno ispirato una sezione del SismaBonus che prevede un miglioramento di classe anche se vengono ripristinate solo le connessioni, che un tempo erano realizzate solo per attrito tra le superfici di appoggio.

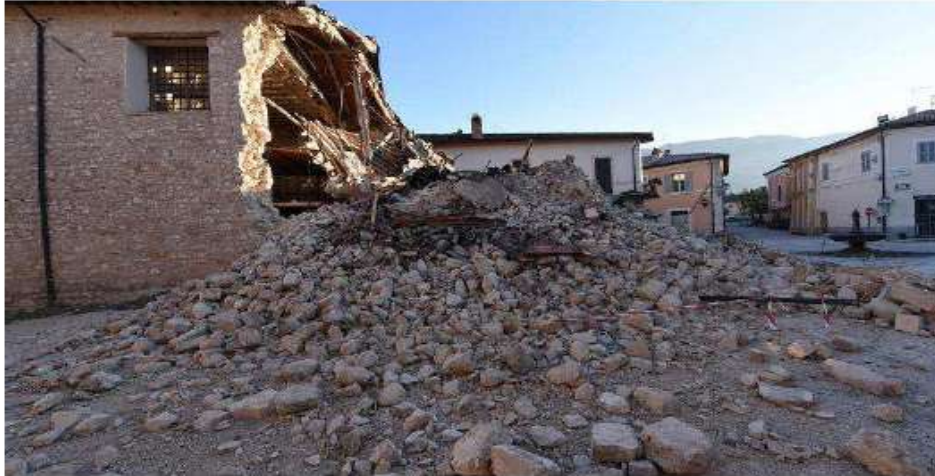
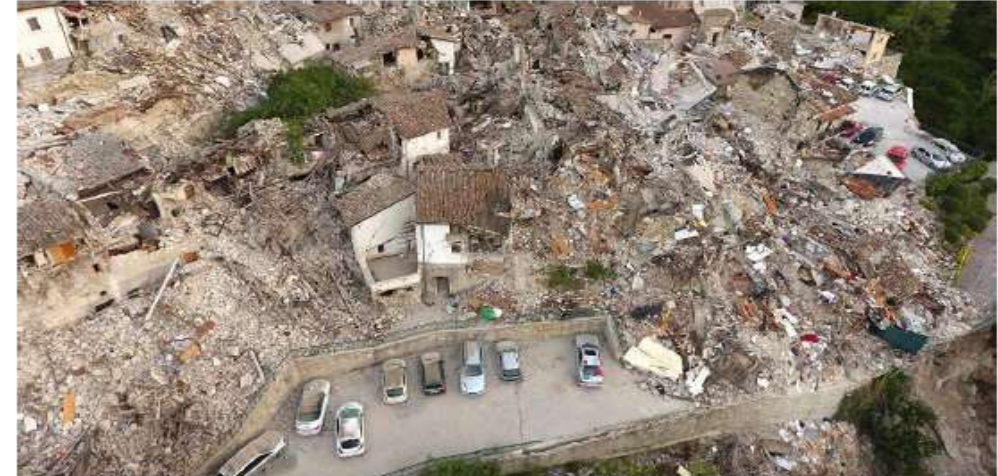
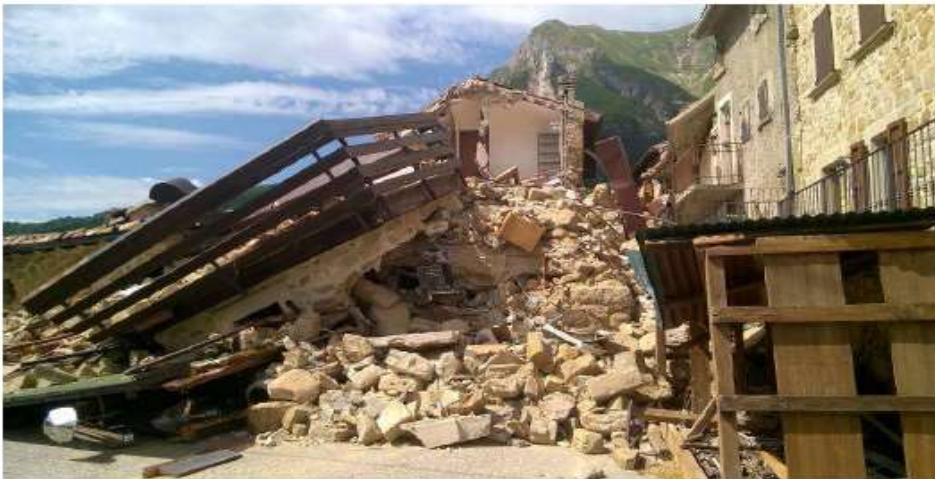
IL SISMA IN CENTRO ITALIA DEL 2016 – Differenza dell'aspetto delle macerie

I crolli si sono verificati prevalentemente in edifici con struttura portante in pietre irregolari; pochissimi crolli tra gli edifici con struttura in muratura e ancora meno per gli edifici in c.a. (ad eccezione della palazzina popolare di Amatrice sotto indagine della magistratura).

Differenza sostanziale dell'aspetto delle macerie:

Dopo il crollo, è impossibile riconoscere la forma dell'edificio e la conformazione strutturale originaria; non ci sono porzioni intatte (setti murari), ma ci si trova di fronte ad un ammasso indistinto di pietrame; **L'ing. Massimo Mariani**, membro del C.N.I. ed uno tra i più esperti in materia, ha paragonato le immagini dei paesi visti dall'alto ad eventi franosi (Convegno presso il Politecnico di Milano del 15 novembre).

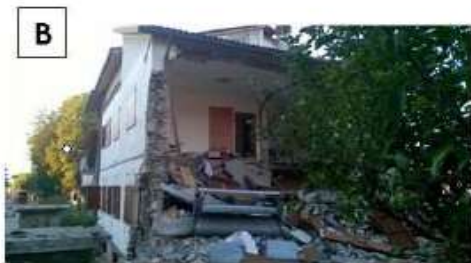
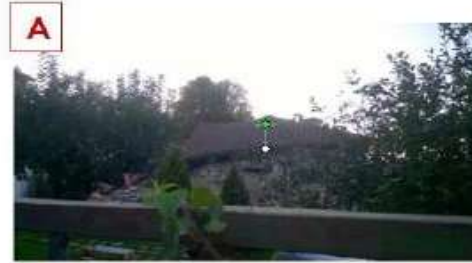
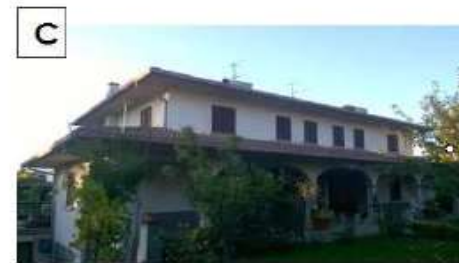
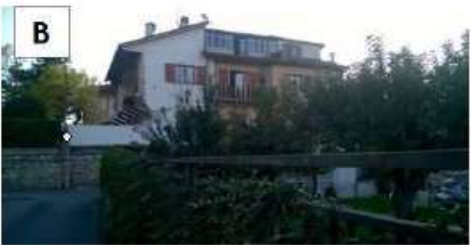
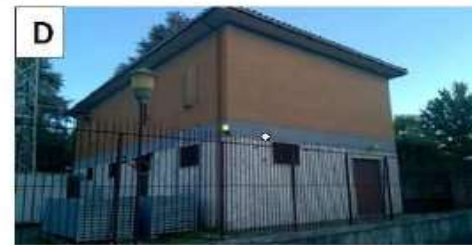
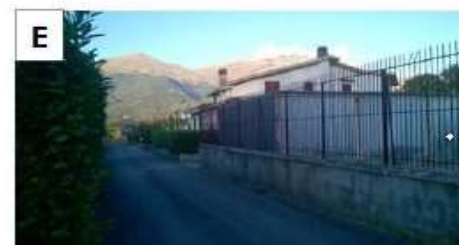
AMATRICE:

Una sequenza fotografica ruotando di 360° la presa (punto rosso); la distanza tra gli edifici più significativi è di circa 10m:

- L'edificio A, è completamente crollato
- L'edificio C, a soli 10m da "A", non ha subito danni.
- L'edificio B è parzialmente crollato (sventrato)
- L'edificio D, opposto ad "A", è integro
- Nel resto della via gli edifici (E ed altri), sono rimasti integri.

L'edificio crollato è in muratura di pietre stondate, malta povera ed ha un solaio pesante e rigido; le falde del tetto sono quasi integre, segno che il solaio ha fatto come da coperchio. E' evidente che in questo caso, più di ogni possibile effetto di amplificazione geologica locale, ha pesato la scarsa qualità costruttiva dell'edificio.

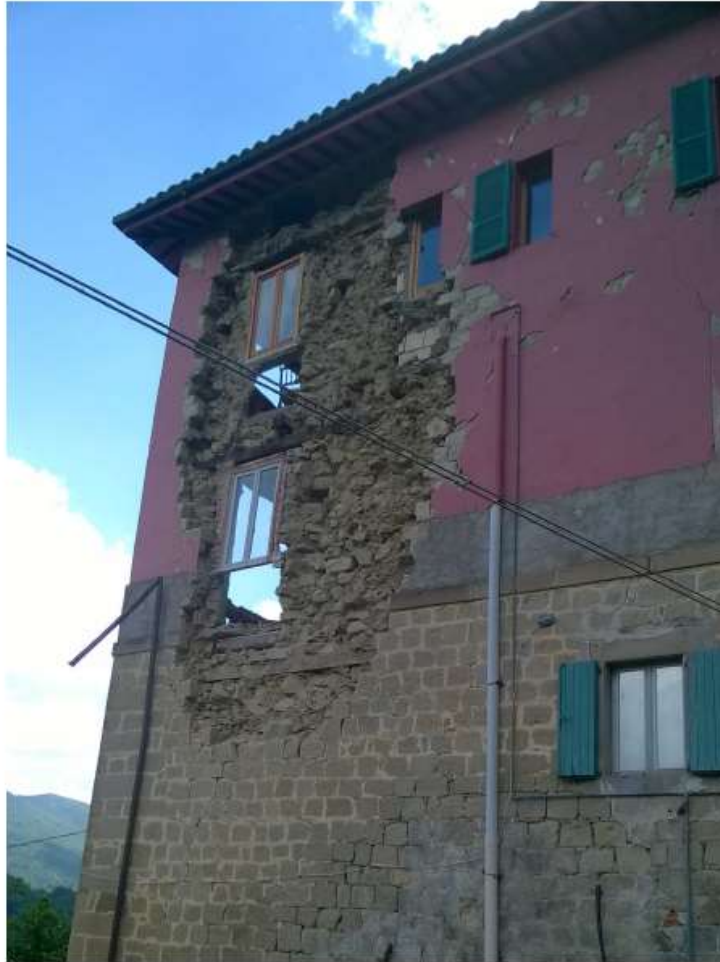
FRAGILITÀ MURARIA / RESISTENZA DI EDIFICI CON INTERVENTI STRUTTURALI

Estrema fragilità della tipologia muraria in pietre irregolari.

I telai delle finestre sono integri ed anche i loro vetri; attorno la muratura si è disarticolata e crollata. Risultano completamente ribaltate le scale di fragilità del comune pensiero.

In questo muro non c'è traccia dell'instaurarsi di un meccanismo resistente e del superamento di una soglia di resistenza dei materiali, ma si assiste solo al totale sgretolamento del manufatto, che avviene prima ancora che i vetri si rompano.

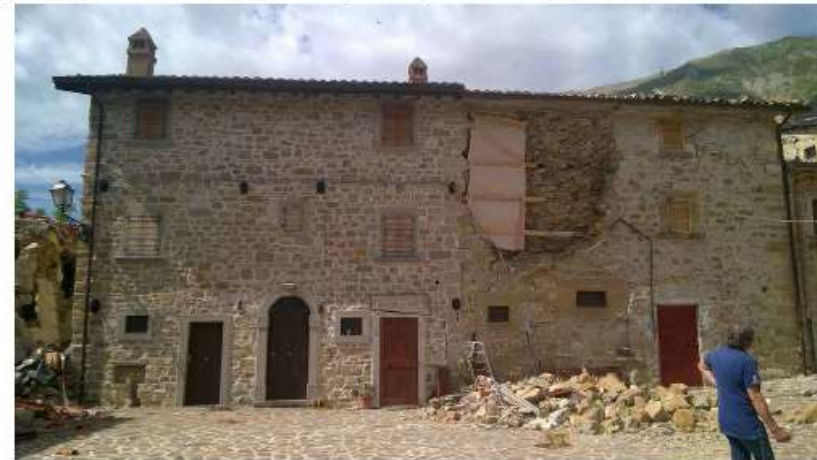
Qualcosa si è salvato: **Gli edifici sui quali sono stati fatti interventi corretti hanno resistito:** a Montegallo, nell'edificio a sinistra, due interventi: catene e rifacimento dei giunti tra le pietre hanno evitato crolli rovinosi, che si sono invece avuti in quelli adiacenti, evidentemente privi di manutenzione, hanno subito crolli parziali. Questi tipo di interventi sono un ottimo esempio di quello che si può ottenere con una adeguata prevenzione.

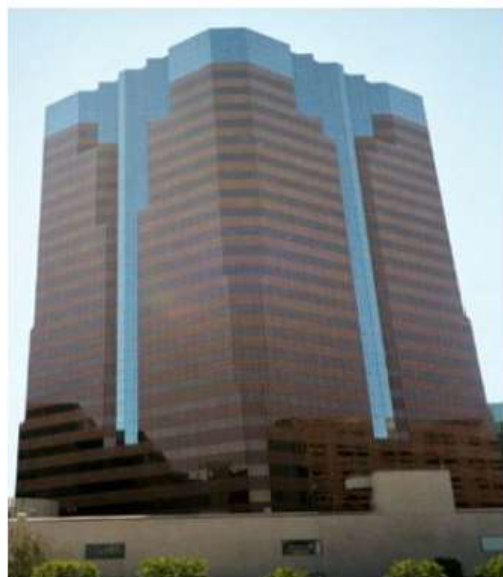
S1 : Strutture in Acciaio a Telai

S1
Steel moment-resisting frame

(VH) = 1.5
(H) = 2.1
(MH) = 2.3
(M) = 2.7
(L) = 3.8

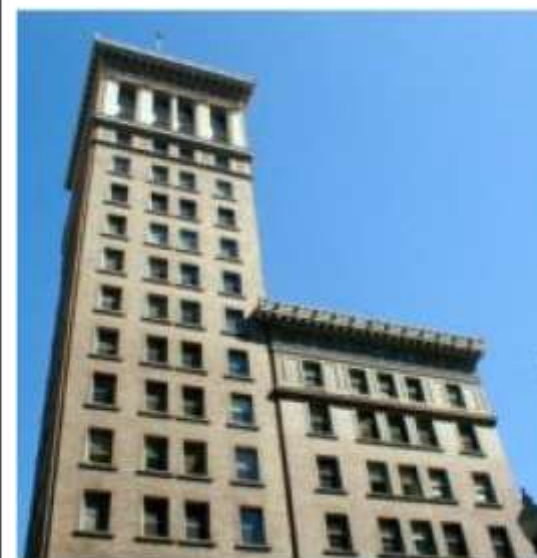
S5 : Strutture in Acciaio e murature di tamponamento

S5
Steel frames with unreinforced masonry infill walls

(VH) = 1.2
(H) = 1.7
(MH) = 2.0
(M) = 2.7
(L) = 4.5

L'effetto delle murature di tamponamento decresce all'aumentare del grado sismico.

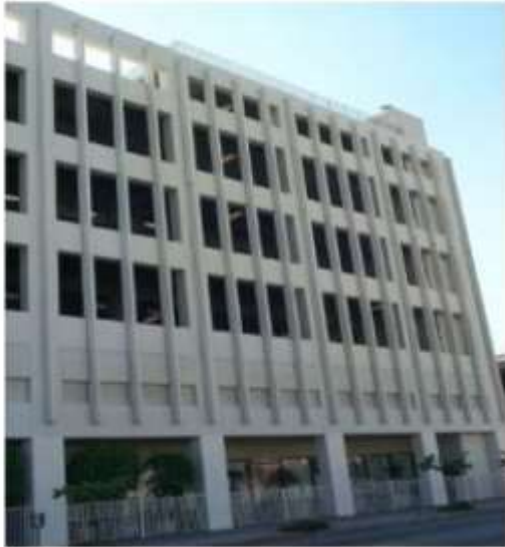
C1 : Strutture in C.A. a Telaio

FEMA Building Type	Photograph	Basic Score
C1 Concrete moment-resisting frames

(VH) = 1.0 (H) = 1.5 (MH) = 1.7 (M) = 2.1 (L) = 3.3

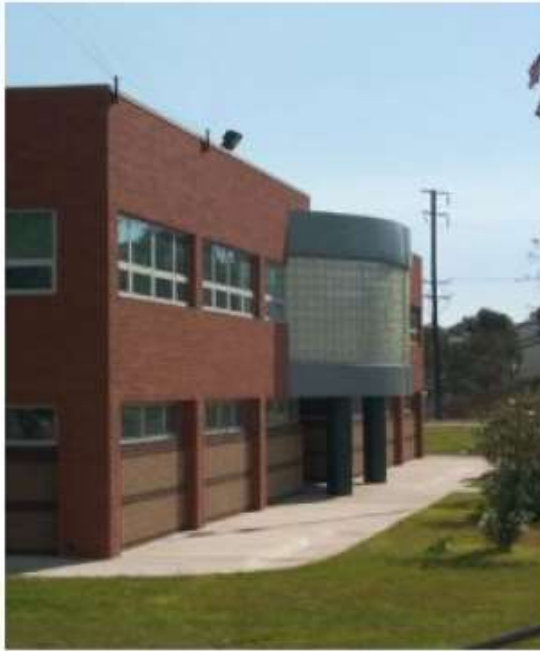
RM2 : Strutture in Muratura Rinforzata

RM2
Reinforced
masonry buildings
with rigid
diaphragms

(VH) = 1.1
(H) = 1.7
(MH) = 1.8
(M) = 2.1
(L) = 3.7

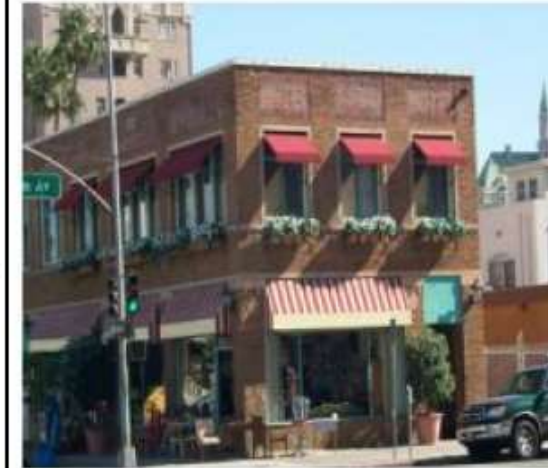
URM : Strutture in Muratura Semplice

URM
Unreinforced
masonry buildings

(VH) = 0.9
(H) = 1.0
(MH) = 1.2
(M) = 1.7
(L) = 3.2

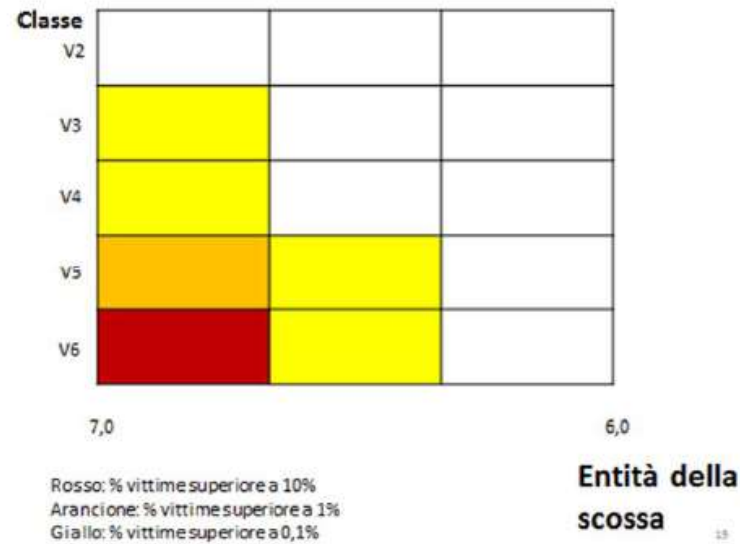
si vede nella figura 4.2, infatti, la probabilità di perdite umane, in presenza di eventi sismici di magnitudo elevata, cresce in modo esponenziale negli edifici caratterizzati dalla maggiore vulnerabilità (classe V6)⁵⁰.

Figura 4.2 - Relazione tra vulnerabilità, magnitudo e danni umani

Per minimizzare le perdite di vite umane occorre, quindi, focalizzare immediatamente l'attenzione sugli edifici con vulnerabilità V6 localizzati nelle aree a maggiore pericolosità sismica.

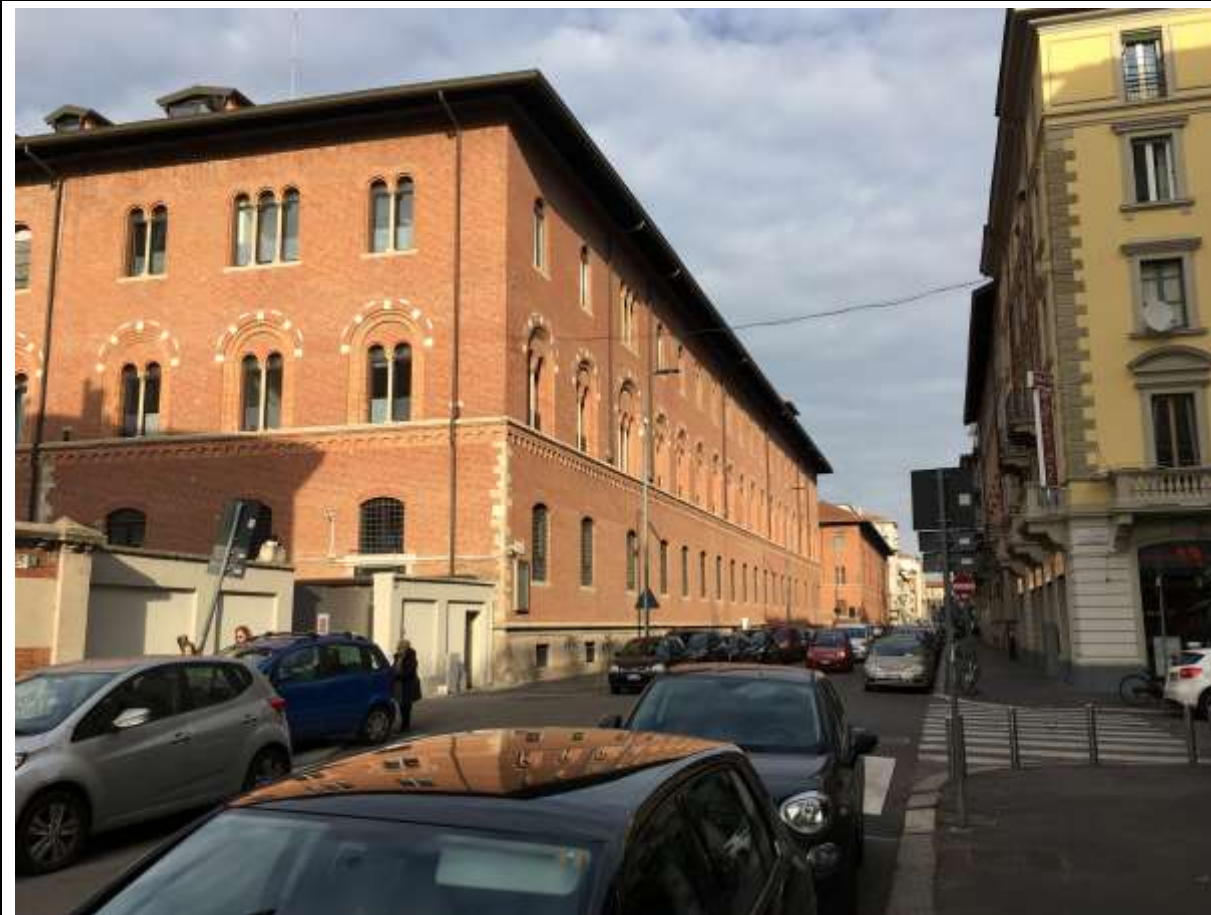
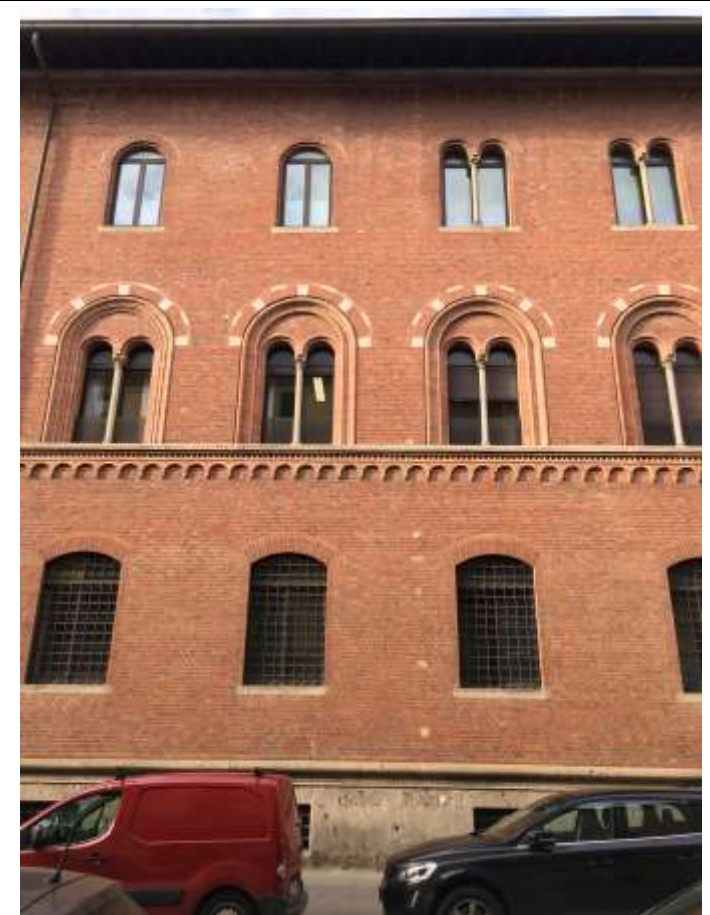
UN BRAVO EDIFICIO

Murature Massicce, in buono stato e ben organizzate

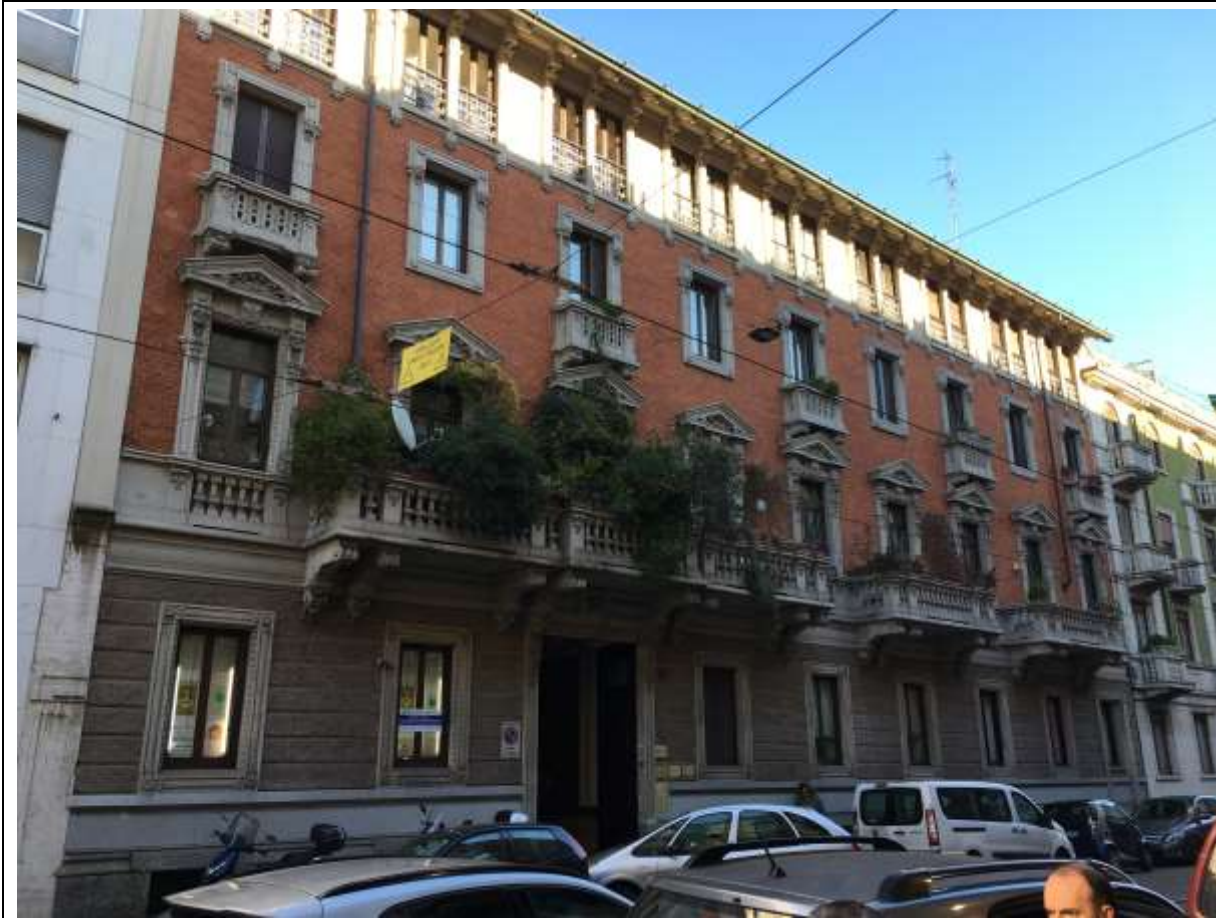
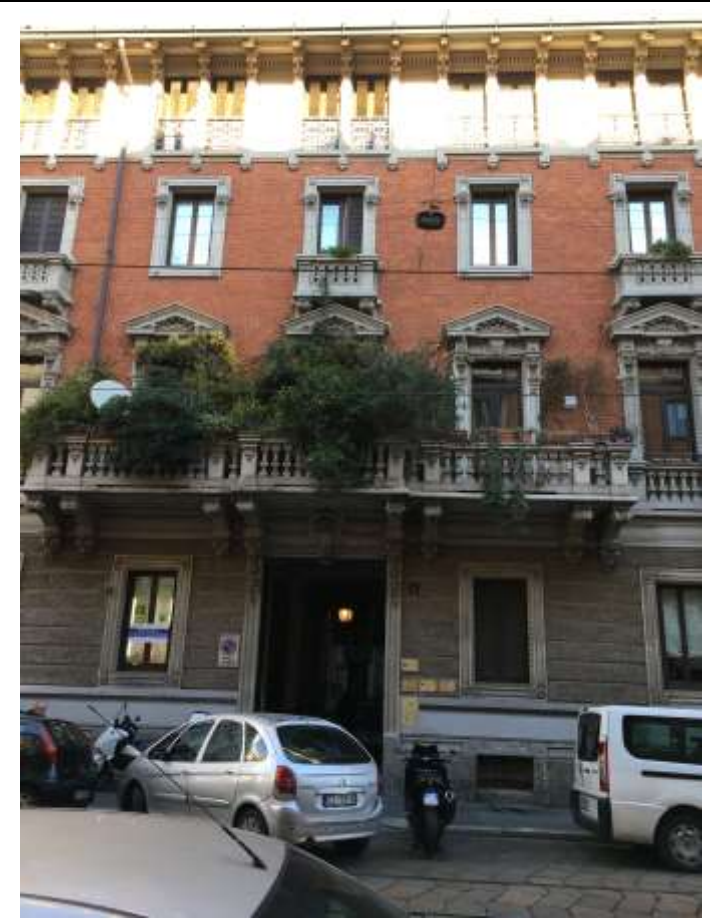
UN EDIFICIO “CATTIVELLO”

Sembra Fortissimo ma.... Serramenti a Scorrere Muri più piccoli di quel che sembra
